Structures Technical Memorandum 328

RESONANCE TESTS ON A PIPER PA-32R TAILPLANE  
BEFORE AND AFTER DAMAGE

A. GOLDMAN and B. QUINN

Investigations have been carried out, on the tailplane of a Piper PA-32R aircraft, to determine the effect of damage, in the form of a split in the underside skin, on the modes of vibration of the tailplane. Details and results of the investigations are described.

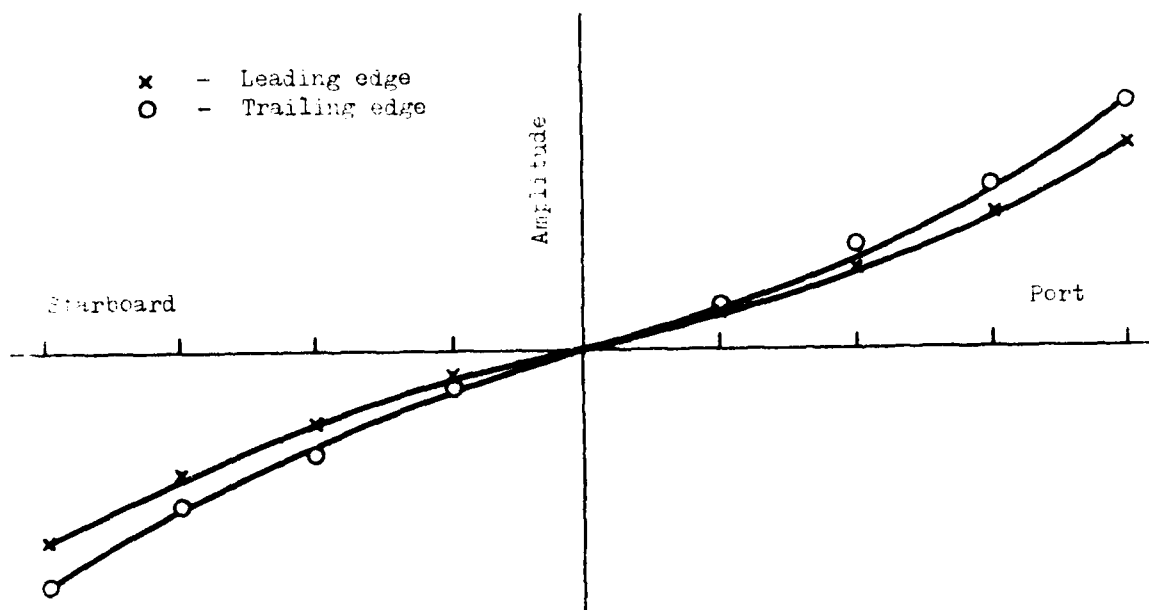
FIG.5 (a) UNDAMAGED TAILPLANE MODE AT 16.85 Hz

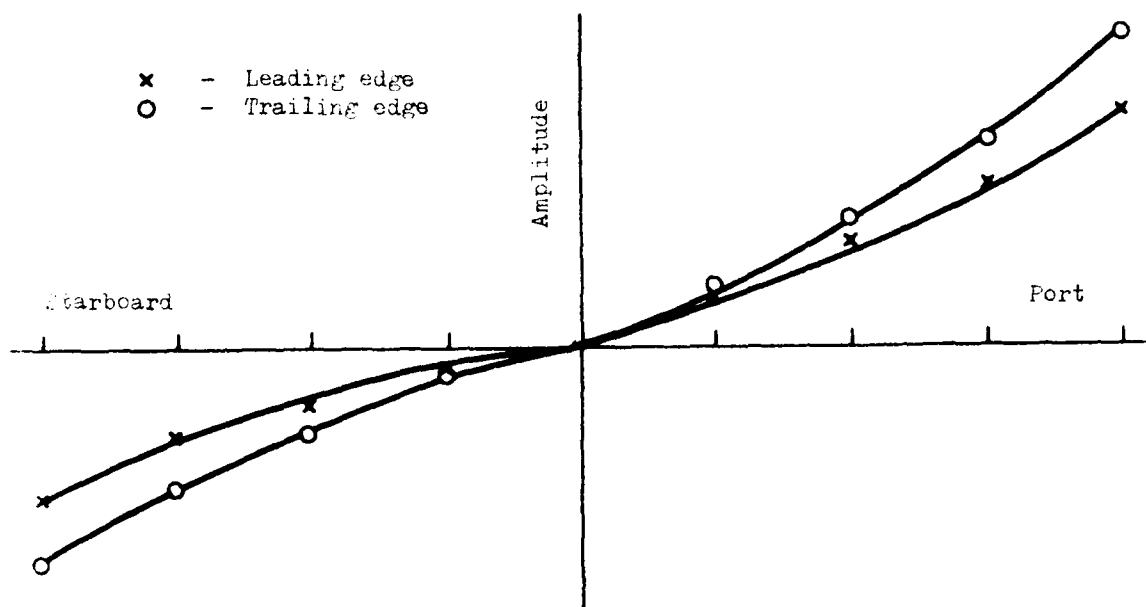
The modes of vibration up to 50 hertz have been plotted for the undamaged and damaged tailplane; the changes brought about by the reduced stiffness are slight.

FIG.5 (b) DAMAGED TAILPLANE MODE AT 16.2 Hz

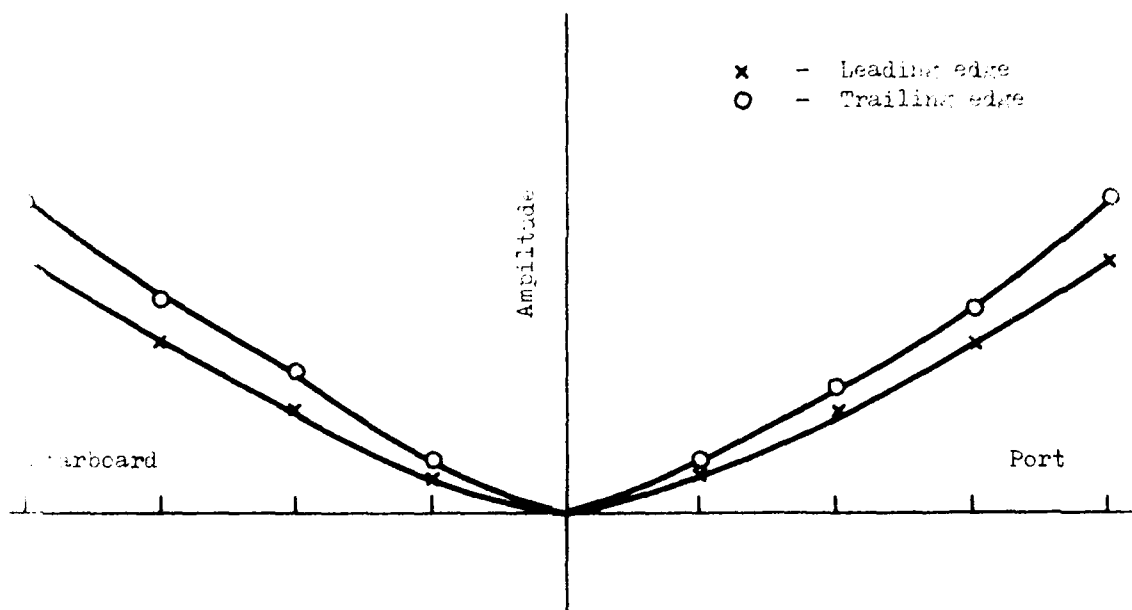
FIG.6 (a) UNDAMAGED TAILPLANE MODE AT 18.55 Hz

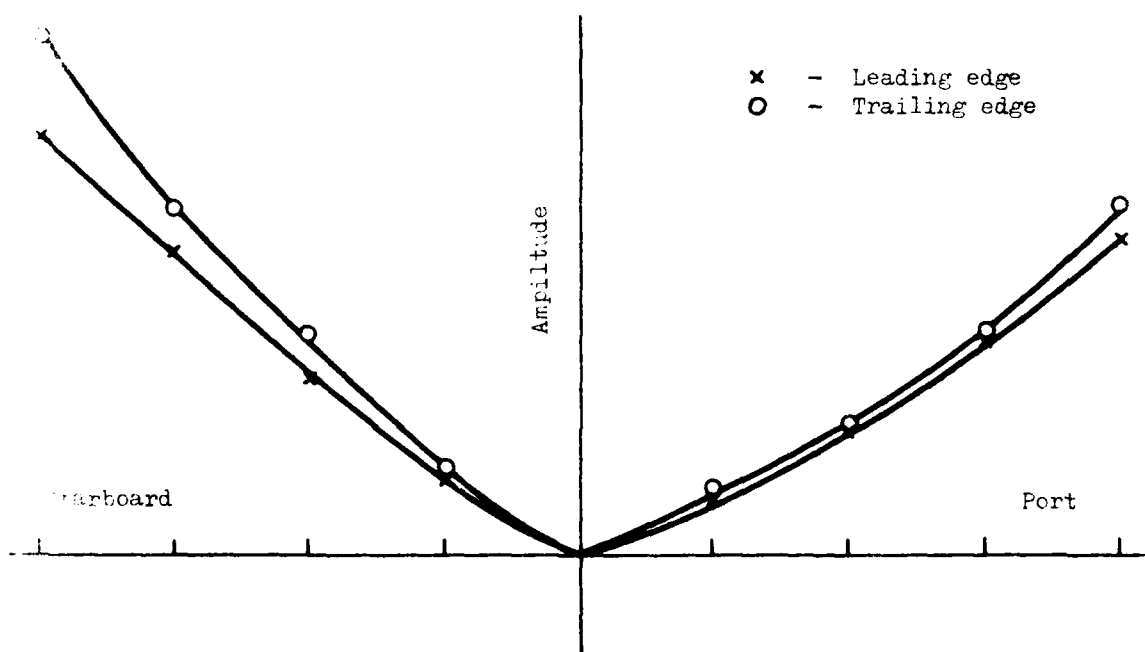
FIG.6 (b) DAMAGED TAILPLANE MODE AT 18.25 Hz

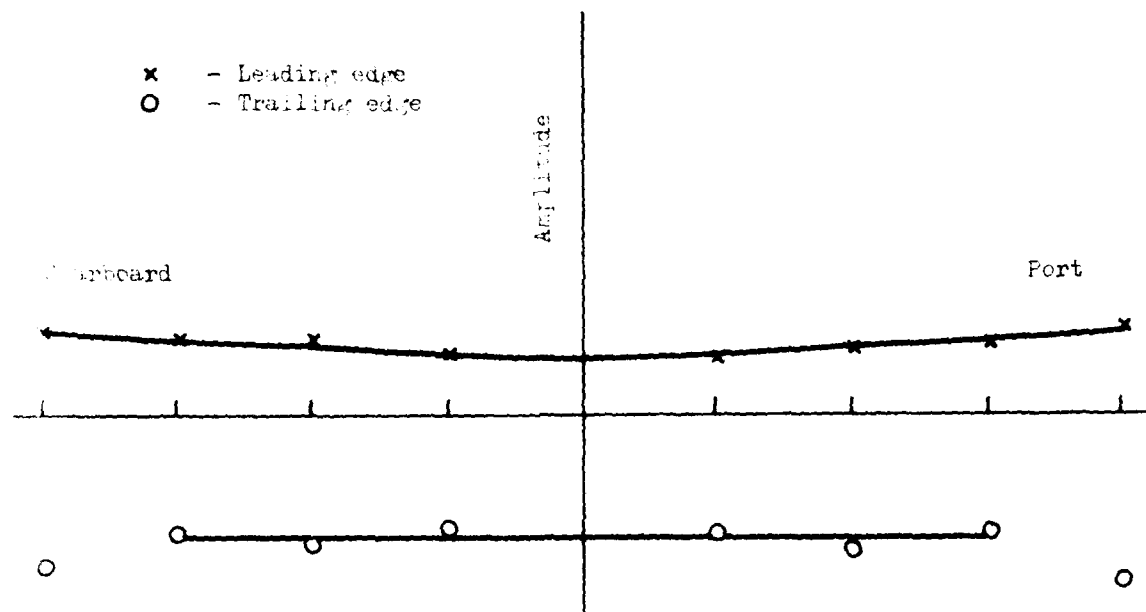
FIG. 7 (a) UNDAMAGED TAILPLANE MODE AT 30.4 Hz

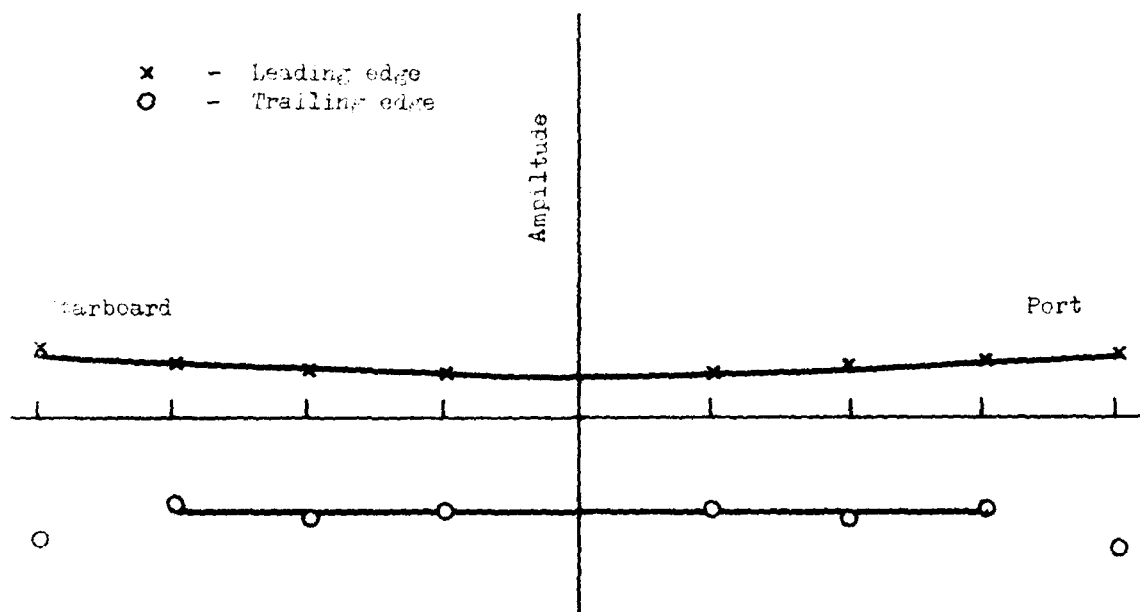
FIG. 7 (b) DAMAGED TAILPLANE MODE AT 29.5 Hz

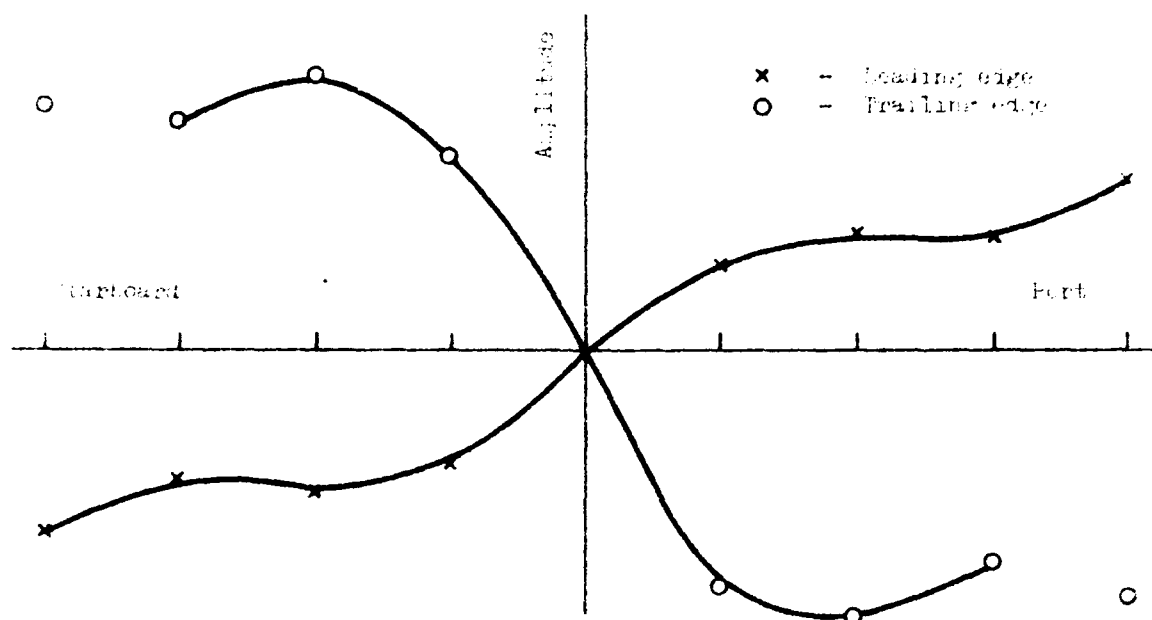
FIG. 8 (a) UNDAMAGED TAILPLANE MODE AT 30.03 Hz

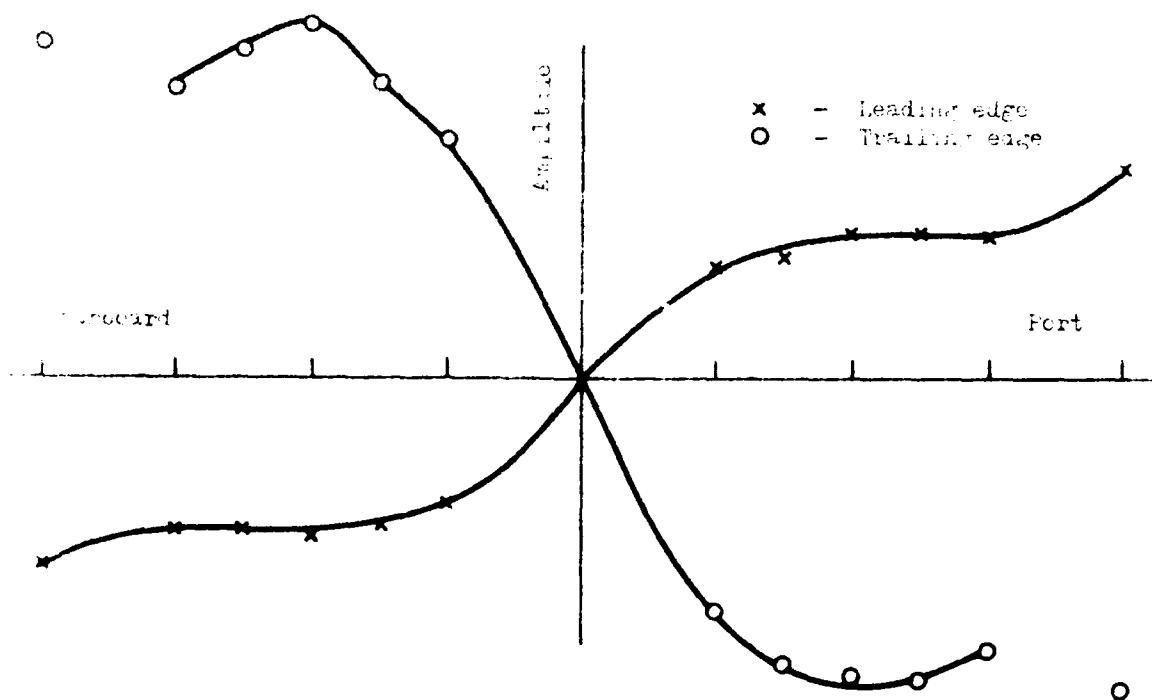
FIG. 8 (b) DAMAGED TAILPLANE MODE AT 48.8 Hz
